Structural Concrete Repair

Wolverhampton University Fire Damaged Column Repair

Client
Wolverhampton University

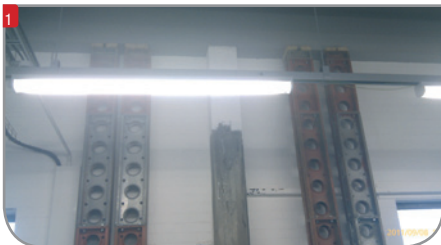
A designed support system from RMD was utilised to act as temporary support to the roof structure whilst the column was being broken out and repaired. This transferred the entire load that the column was carrying down through the concrete floor slab to the existing ground beam.

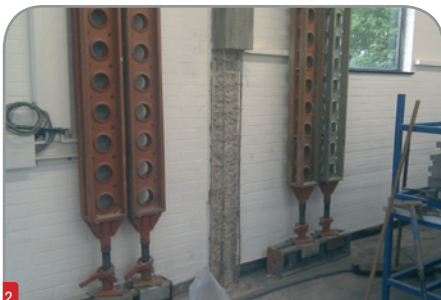
A fire within the Arts Department of Wolverhampton University caused damage in the form of structural spalling and cracking to a reinforced concrete support column. Freyssinet Limited were appointed by Wolverhampton University to carry out structural repair to the column, which included setting up a support system, breaking out the fire damaged concrete and repairing. Freyssinet offered the University a quick mobilisation to attend site, complete the works with minimal disruption, and demobilise prior to the Arts Department being functional again.

Once the support system was in place operatives commenced breaking out and saw cutting to form a neat edge. However, once the initial repair was broken out further damage was apparent and the repair doubled in size up to 2.8m which required shuttering and pouring in two operations. 5 star repair concrete was used for the repair, and the newly formed column could not have any imposed loading applied until it gained 30N/mm².
