Concrete repair to pretensioned beam

Whittlesford Station Bridge, Cambridge

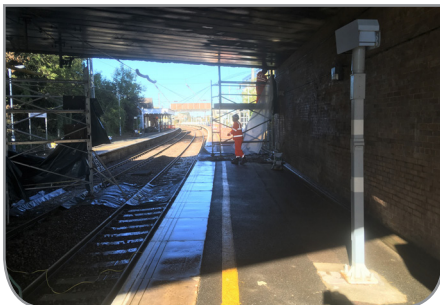
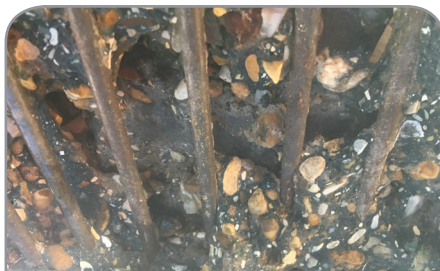
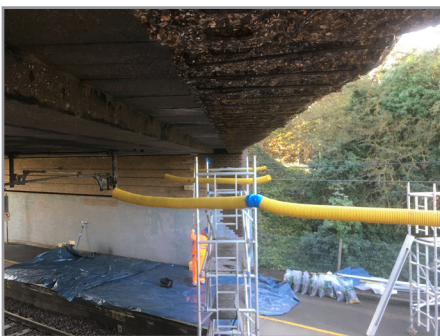
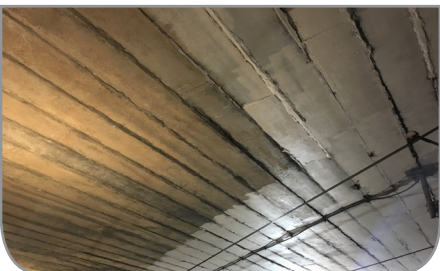
The investigation works to the northern edge beam consisted of removing the defective cover concrete using hydro-demolition to expose the lower level of pre-tensioning wires. This work was done on 31st October during a 27-hour possession. The access was via normal aluminium scaffold towers, these being robust enough to withstand the lateral thrust that you get when using hydro-demolition. The ballast was sheeted to prevent contamination and the area was enclosed with vertical sheeting to contain debris.

The wires were found to be corroded through and therefore contributing no structural strength. Two channels were cut across the beam at the third-span points using hydro-demolition in order to check the condition of the second layer of wires and these were found to be in good condition. This meant that the Engineer's provisional design was validated, and repair works could progress at the next available series of possessions.

The strengthening works involved fixing two new 15.7mm diameter post-tensioning strands to the outer face of the northern edge beam. The anchorage was the Freyssinet 1R15 system. This had a housing that accommodated the wedge anchor that grips the strand and a hole through which a 25.5mm diameter high tensile Freyssibar was inserted to fix the anchor to the structure.

The two strands were to be fixed to a deflected profile so two galvanised steel deviators had to be fixed at third-span points. Greased and plastic-coated strands were threaded through plastic ducts which, in turn, passed through the deviators. The ducts were grouted prior to stressing the strands, this ensured there were no hard points of support through the deviators and gave a total of four layers of corrosion protection.

The soffit of the beam, previously removed to expose the corroded strands, was repaired using Renderoc HB30 applied by hand over several Saturday night RoR possessions.

Anti-carbonation coating was applied to the whole soffit of the bridge.
