Concrete Repair & Cathodic Protection

Harlech Swimming Pool, Harlech, Wales

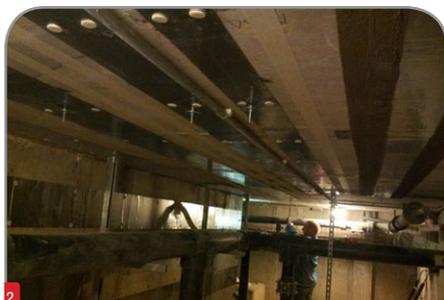
The perimeter crawl ducts where the works were to be carried out were classified as confined space, therefore, careful planning, correct equipment and monitoring as well as competent certified personal was all essential to complete the project in a safe manner.

- 1 Harlech Swimming Pool
- 2 The crawls ducts were classified as confined space
- 3 Exposed rebar / Concrete repair
- 4 Installation of the CP system

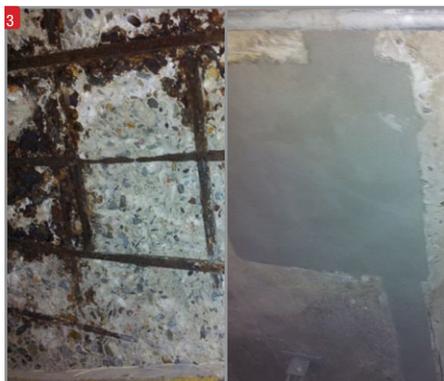
Results of the survey found there to be deteriorating reinforcement steel within the crawl duct walls and soffit, along with areas of cracked and spalling concrete. Freyssinet put forward a solution of concrete repair and the installation of a cathodic protection (CP) system, appointing their sister company CP specialists Corrosion Control Services Limited (CCSL) to provide the design and specification for the CP system.

The project was completed in two stages. Initially, Freyssinet broke out all delaminated and spalled concrete, then tested and ensured continuity of the reinforcing steel and completed concrete repairs. The repair areas were then allowed to cure prior to the installation of the ZLA "sticky zinc" galvanic CP system. The locations of zinc were marked out on the walls and soffit, and small pockets were broken out to allow for studs to be welded to the reinforcement and then electrically connected to the ZLA.
