## Concrete Repair

Westminster Bridge, Ellesmere Port

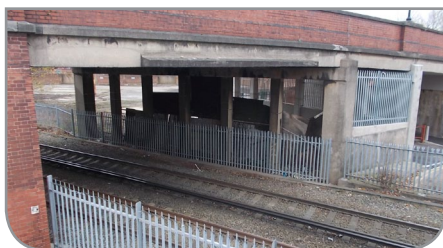
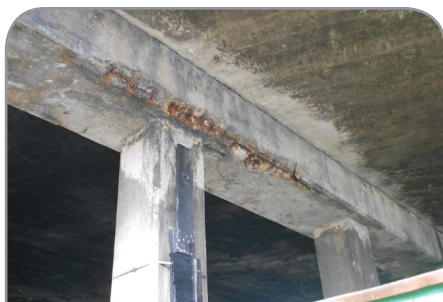
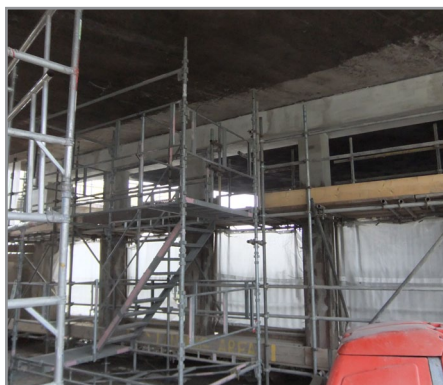
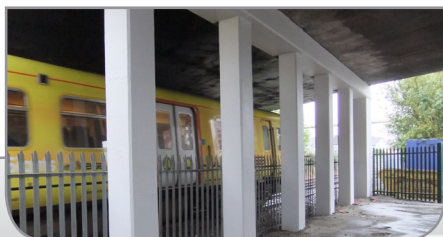
Westminster Bridge carries the A5032 Whitby Road over the Ellesmere Port to Frodsham railway line and a local access drive. The three span concrete bridge was built around 1960. The deck is made from steel beams encased in concrete and the support piers and abutments from reinforced concrete.

Each pier comprised of seven columns and a crosshead beam. Both piers needed work, with the north pier in particularly poor condition, suffering from de-lamination, spalling, corroding reinforcement, cracking and surface staining. While these major concrete repairs were carried out underneath, two-way traffic was maintained on the bridge with lanes reduced in width. Footways for pedestrians also remained open.

Preparation: The areas to be removed were agreed by visual survey and hammer-tap testing in conjunction with the council's engineer. Prior to breaking out concrete with hand held breakers, the edges of the break-out area were pre-cut by saw. Concrete was removed back to 30mm behind the reinforcement. All surfaces of steel reinforcement were mechanically abraded to remove corrosion.

The concrete repair works: Sika MonoTop 610 primer was applied, one single coat to concrete and two coats to exposed reinforcement. This was followed by Sika Monotop 615 repair mortar, applied by hand whilst the bonding primer was still wet (wet on wet). Where layers needed to be built up to prevent sagging or slumping, each layer was allowed to stiffen before the subsequent layer was applied. If more than 24 hours elapsed between layers then an additional coat of Sika Monotop 610 was applied.

The cathodic protection: This comprised of the installation of XP2 galvanic anodes within the repair areas, supported by CC 100 galvanic anodes installed into drilled holes elsewhere on the pier.

The fairing coat: Once the concrete repairs and cathodic protection works had been completed, the crosshead and piers were over-coated with Renderoc FC. Prior to trowelling on the Renderoc FC, the concrete surface was pressure washed to remove any dust and unsound material. This cleaning operation could only be carried out during rail possessions.
