## Epoxy Resin Crack Injection

Wimbledon Train Maintenance Depot

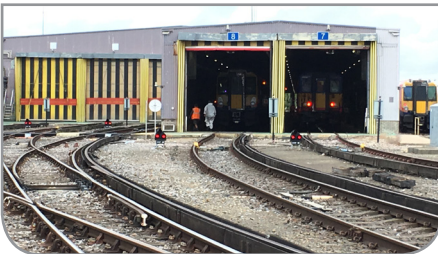
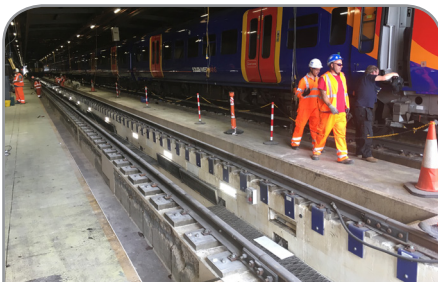
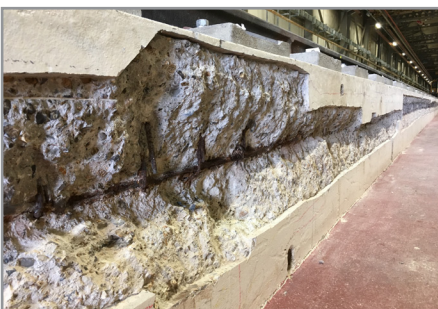
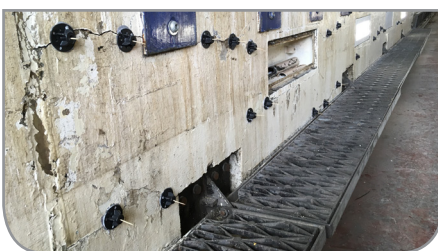
Wimbledon Train Maintenance Depot services the train fleet for South West Trains. Maintenance Road 7 is approximately 250m long and comprises two concrete up stand walls 1130mm high by 460mm wide, which support the running rails. The walls were built within a pit which enables maintenance staff to access the underneath of the train from directly beneath and from the outside face.

The facility was built in the early 20th Century with mass concrete walls. It was repaired in the 1970s with reinforcement added local to the wall-tops to resist cracking induced from the rail shoes. Freyssinet was engaged in 2017 to remedy further cracking that afflicted 90% of the length of both walls. Horizontal cracks were visible on the inner and outer faces and a central vertical crack was found in some locations by taking cores. Stray currents had been detected by the Engineer which were possibly causing corrosion of the reinforcement.

- removing a band of render (saw cutting to form a neat edge) to gain access to the surface of the structural crack,
- drilling and fixing injection packers at approximately 300mm centres to intersect the crack,
- sealing the crack surface with TamRez 310 putty,
- injecting cracks with TamRez 220 epoxy resin,
- re-applying render,
- applying concrete repairs using Renderoc HB repair mortar,
- repainting with three-coat Pumacoat system.

The works were done in three phases to suit continuing train maintenance obligations and took nine weeks. A total of 1150 linear metres of cracks up to 5mm wide were injected.
