Wepener Bridge Concrete Repairs & Cathodic Protection

Tickford Roundabout, Milton Keynes

Client
Milton Keynes Council
Principal Contractor
Ringway
Works Commenced
March 2019
Works Completed
May 2019

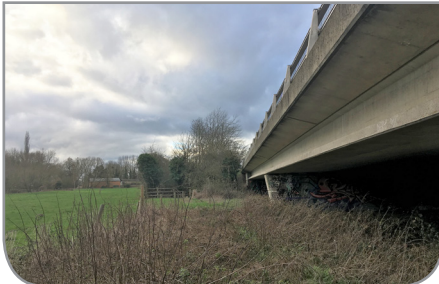
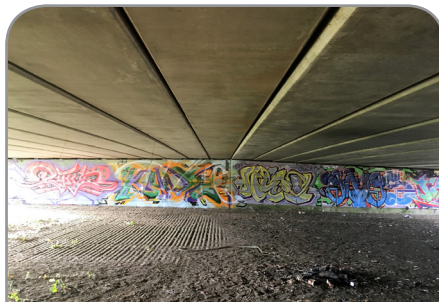
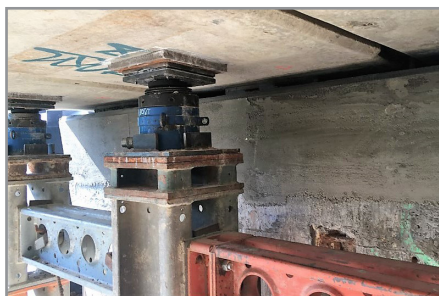
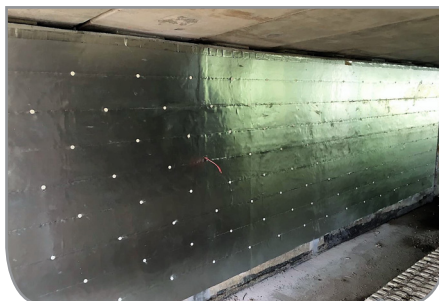
The works were carried out during one continuous 10-week visit, beginning with temporary works installation. A total of 31 R.M.D props with HFG 1002 jacks and sliding plate system were installed either side of both piers, prior to hydro demolition. All repair works were sequenced due to design constraints resulting in only three jacks being engaged per span at any one time. Once the concrete repairs had taken place and sufficient curing and strength gain was achieved, the Cathodic Protection phase of the works could be undertaken.

All negative, positive, test connections and reference electrodes were installed prior to the Zinc foil anode being applied to each pier, which was coated with a mesh and cementitious topping layer for protection and waterproofing. The monitored Zinc Layer Anode (ZLA) system has a bespoke iGAL battery operated system, which will provide on-going performance data from the reference electrode and its protection of the structure.
