Fire Damage Repair Scheme

M6 Toll, Dunton Lane

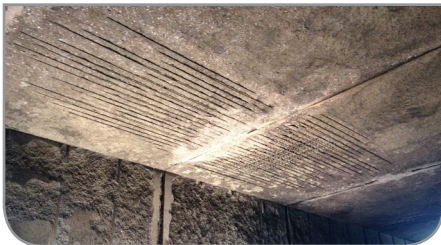
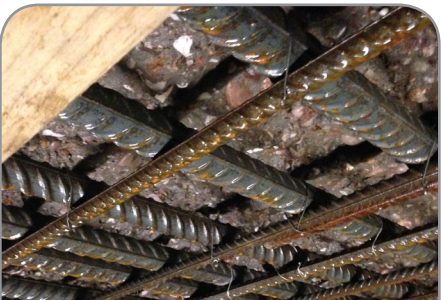
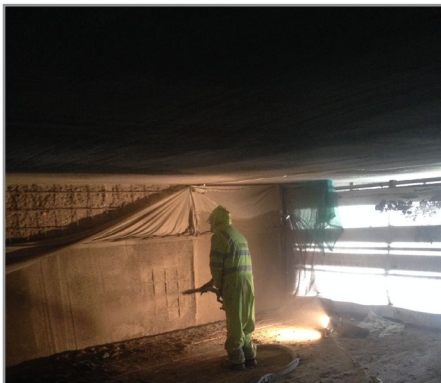
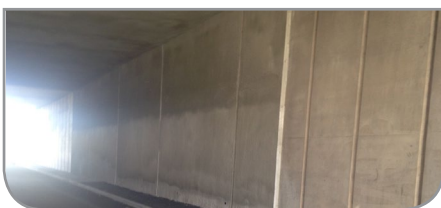
Significant structural damage occurred to the M6 Toll at Dunton Lane underbridge following a lorry fire. The M6 Toll engineering team contacted Freyssinet to assist with the assessment of the damage and work with its design team to produce a suitable repair strategy.

Following technical approval of the repair solution, works commenced on site. The approved repair design consisted of a series of sequenced repairs to the soffit. The repairs were arranged in a 'patchwork' layout, with the intention to remove only a small area of defective concrete from each structural element at any juncture, thus ensuring the integrity of the structure was not put at risk. Once the soffit repairs were complete, Freyssinet undertook wall repairs as the second phase of the works.
