Bridge Strengthening and Bearing Maintenance

M6 Toll Bridges B443 & B518, Warwickshire

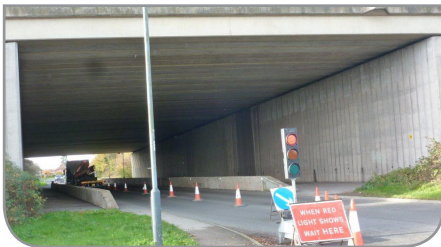
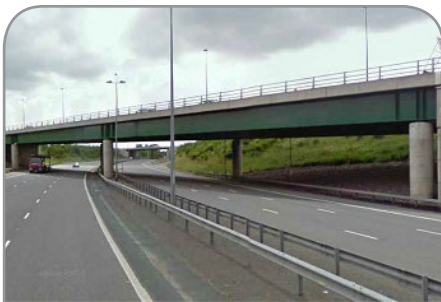
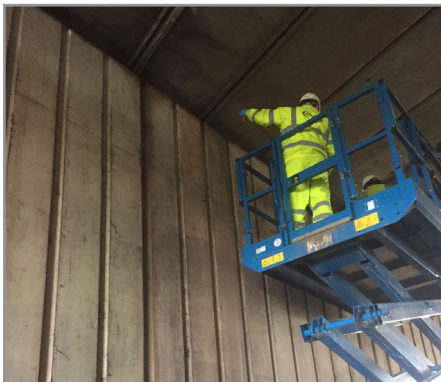
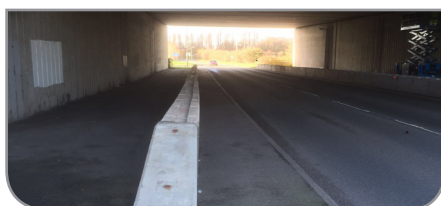
- Scaffold erection to access the work area
- Steel erection
- Hydraulic jacking works
- Installation of permanent steel packing shims

The existing condition and design of the structures meant that the cantilevered approach sections of bridge deck between piers and bank seat were 'bouncing' vertically under live load conditions. Surface cracking had also occurred along the line of the transverse beam on the approach side on both structures, although significantly less pronounced at B443.

The works to all three bridges included cleaning of elastomeric bearings, repairs to mechanical bearings, removal of redundant mechanical bearing baseplates, removal of unnecessary polystyrene from bearings, application of corrosion protection and installation of pigeon netting.
