## Steel Repair, Painting and Jacking

Muller Road, Filton Bank Four Tracking

**Client**  
Network Rail

**Contractor**  
Taylor Woodrow

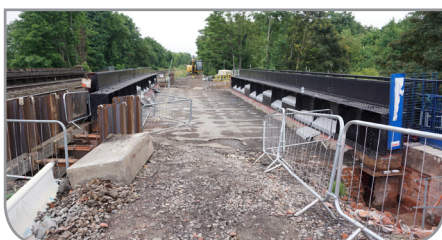
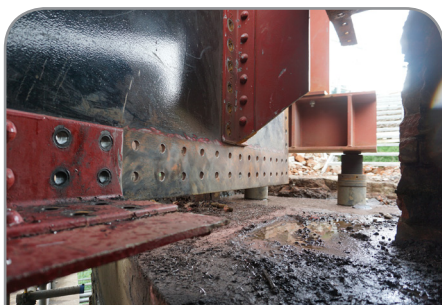
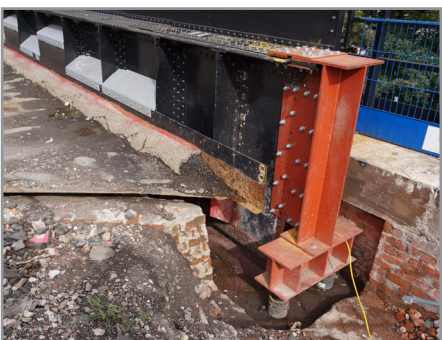
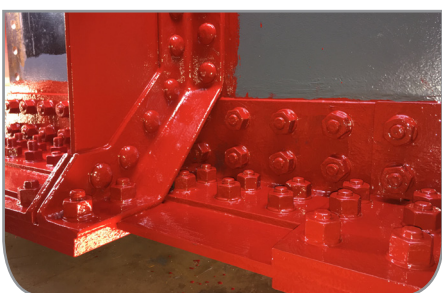
During the earlier refurbishment of Muller Road rail bridge, the ends of the main girders were found to have serious local corrosion where the bridge sat on the abutment. Before being brought back into use as part of Bristol's Filton Bank four tracking project, it was necessary to restore full strength. Principal Contractor, Taylor Woodrow, appointed Freysinet to do this work in July 2017.

After Taylor Woodrow had excavated and demolished the ballast wall, Freysinet removed the girder end plate and installed temporary jacking steel. This comprised of a fin plate with splice plates, stiffeners and a crossbeam, beneath which two HFL-1001 Longstroke (109 tonne) jacks were fitted. There were two main girders like this plus an intermediate crossbeam all to be jacked simultaneously at the north end of the bridge.

Once lifted by 145mm the corroded bottom plate, bearing plate and stiffeners were removed using rivet busting and angle grinders. Burning of steel was avoided altogether in accordance with Network Rail requirements. New plates up to 120kg each were installed using carefully risk-assessed manual handling techniques assisted by lifting with an excavator. New plates were bolted up with tension-control bolts after preparing the faying surfaces. Following application of the three-coat paint system the north end was de-jacked, the temporary jacking steel removed and the girder end plate replaced.

The whole operation was then repeated at the south end.
